# Home Preservation Manual

# Civic Park Home Preservation Manual

TOMBLINSON, HARBURN, YURK & ASSOCIATES INCORPORATED ARCHITECTS AND PLANNERS  
705 Kelso Street  
Flint, Michigan 48506

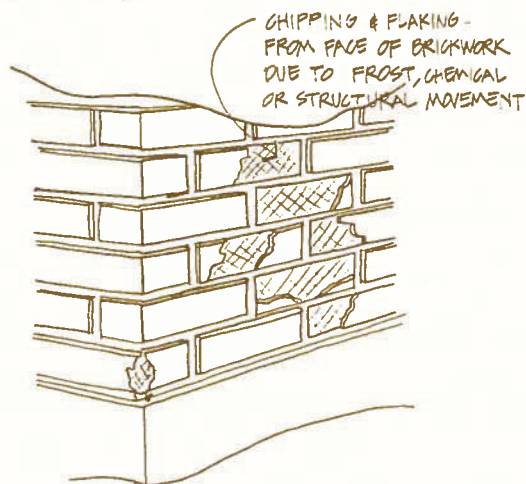
SPALLING OF BRICK

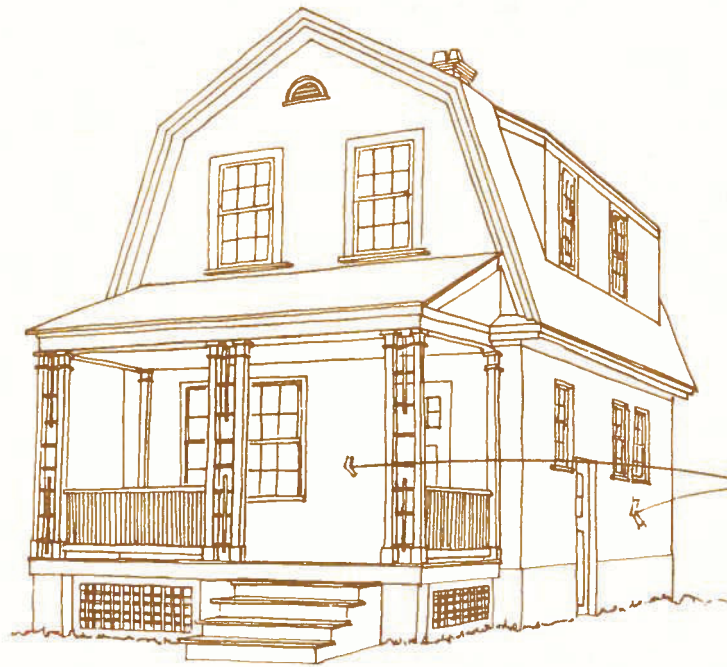
STUCCO ON CLAY  
TILE, SOMETIMES  
ON WOOD LATH.

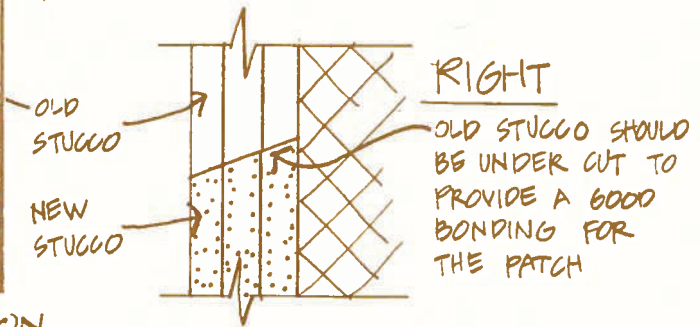
STUCCO REPAIR

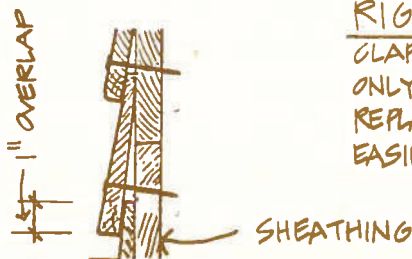
RIGHT  
CLAPBOARD NAILED ONLY AT BOTTOM REPLACEMENT IS EASIER

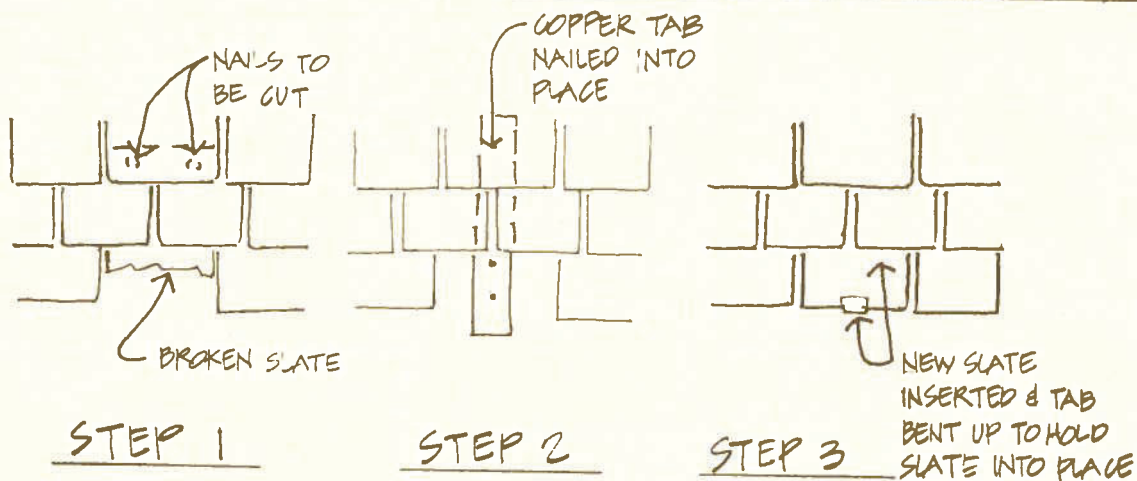
ALTERNATE METHOD OF SLATE REPLACEMENT
